COUNT	DATE	OFFENCE	FACTS	COMPLAINANT	AMOUNT
			<p>1. Amphetamine 0.09mg/kg 2. Methylamphetamine 0.87mg/kg 3. Benzoyllecgonine 0.06 mg/kg 4. Fentanyl 0.007mg/kg 5. Ketamine 0.22mg/kg</p> <p>Doctor Nelle van Buuren, Forensic Medical Officer with Queensland Health, states methylamphetamine is broken down in the body to amphetamine and benzoyllecgonine is a metabolite of cocaine. The presence of amphetamine, methylamphetamine and benzoyllecgonine in the defendant's blood can be explained by the consumption of methylamphetamine and cocaine. The absence of a measureable concentration of cocaine makes it likely that the cocaine was consumed a considerable time before the defendant provided the blood sample. It is further likely that the presence of fentanyl and ketamine is due to the medications administered by the paramedics at the crash scene.</p> <p>Dr van Burren opines that the indicia noted by paramedics, namely agitation, combativeness and high anxiety could be attributable to either :</p> <ul style="list-style-type: none"> (i) the release of stimulatory hormones, such as adrenaline, by the defendant's body in response to his injuries and the crash; or (ii) the effect of the methyla

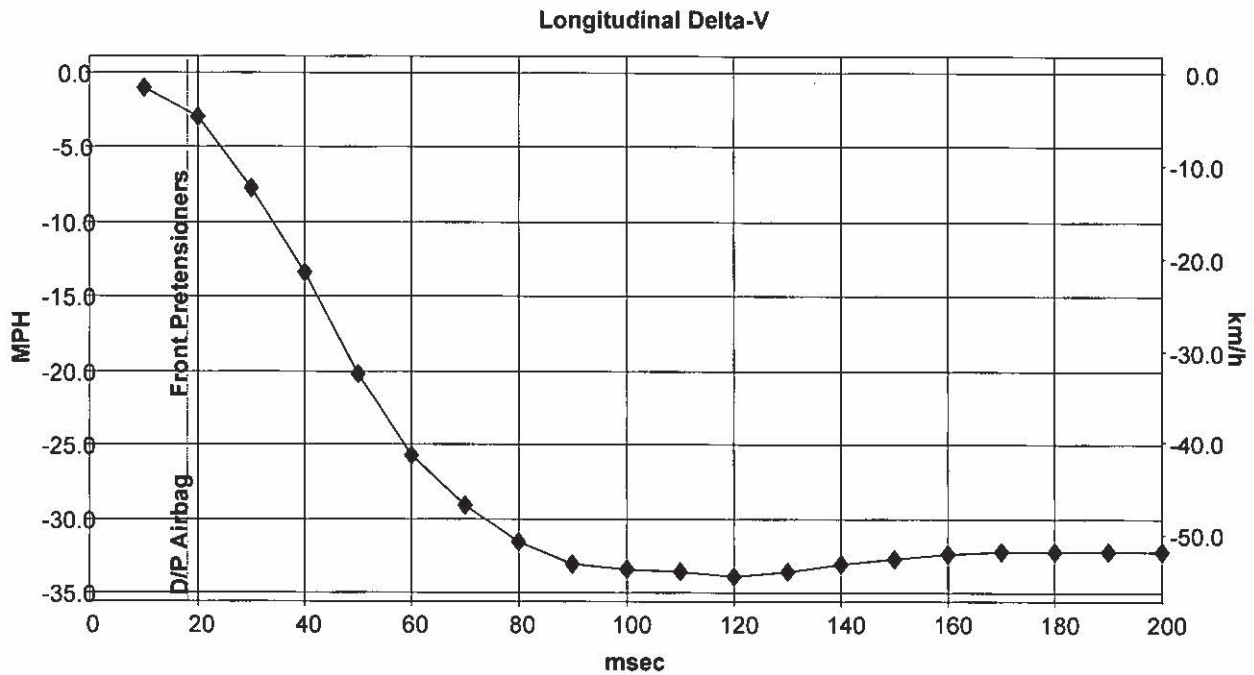
Longitudinal Crash Pulse (Most Recent Event, TRG 3 - table 1 of 2)

Recording Status, Time Series Data	Complete
Max Longitudinal Delta-V (MPH (km/h))	-33.9 [-54.6]

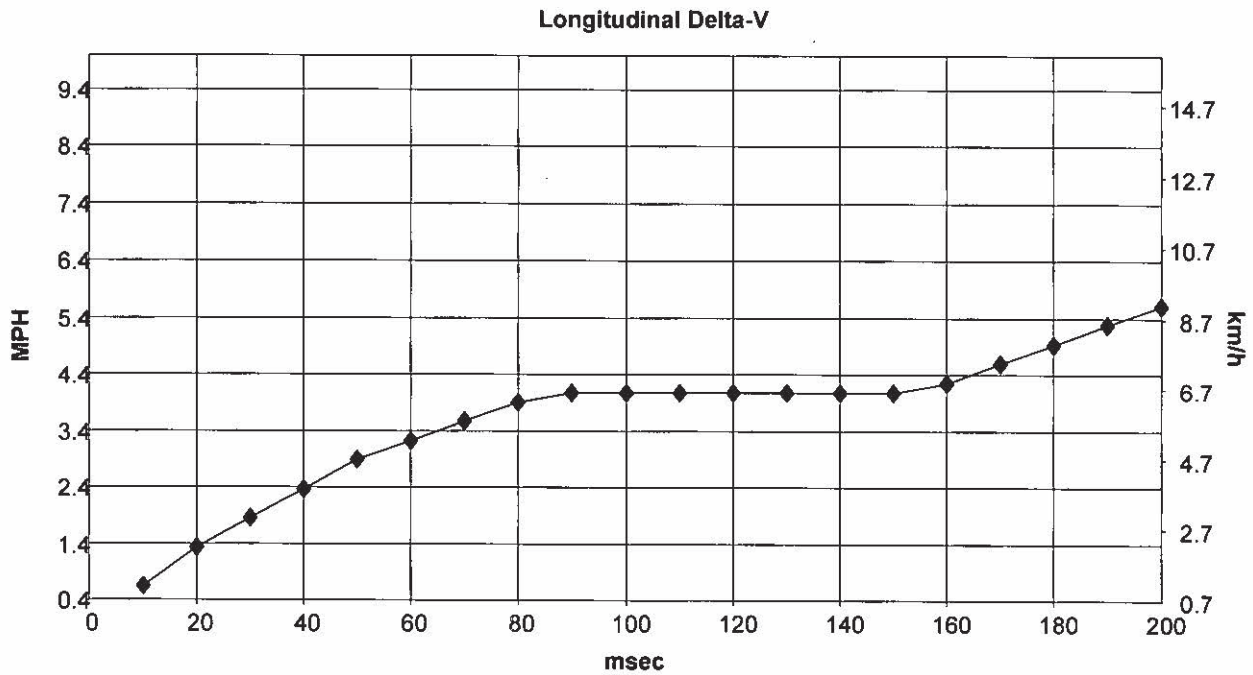
Longitudinal Crash Pulse (1st Prior Event, TRG 2 - table 1 of 2)

Recording Status, Time Series Data	Complete
Max Longitudinal Delta-V (MPH (km/h))	5.7 [9.1]
