A REVIEW OF SPEEDOMETERS AND THE CRITERIA TO BE CONSIDERED BEFORE ACCEPTING 'FROZEN' READINGS AND OTHER MARKS.

Abstract

Various mechanisms have been used to drive speedometers and other instrument gauges. This paper reviews the mechanisms used; in particular stepper motors which have become the most common type in the last decade or so.

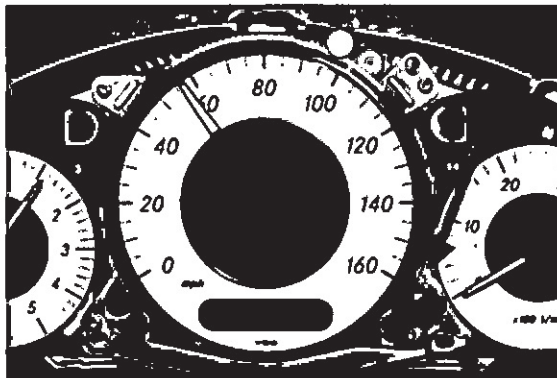
Fig 6 – Ring-style pointer (motor position arrowed)

A few instrument panels, such as those of various models of Mercedes, do not have a central needle. Instead the pointer is part of a large ring that surrounds the dial face. These rings are driven by stepper motors fitted with a spur gear on the spindle. This engages with gear teeth on the outer edge of the ring.

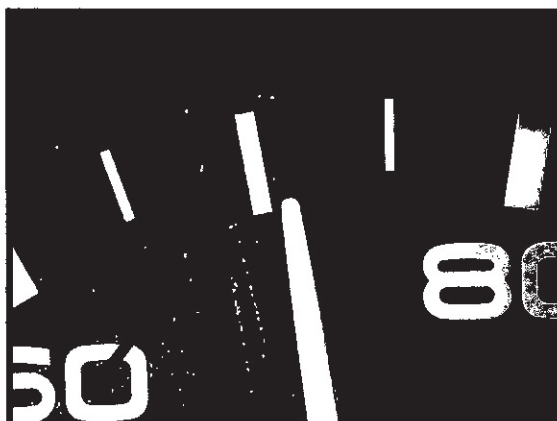
Fig 7 – Witness mark made by the needle (arrowed)

A technique that was used in the examination of crashed aircraft for many years (and probably still is for some small aircraft) was to examine the dial face of the instrument for a 'witness mark'. A similar technique can be used for speedometers. Old-style folded aluminium needles were flexible and could easily strike the dial face, even in road traffic crashes. However, moulded plastic needles used nowadays are much more rigid and, in our experience, marks from these are only rarely encountered.
