Analysis into Vehicle Speed - North Lakes fatality

Reference No. FR 1175167 / ERS 3169615 / QP 1300633856

Fatal Traffic Accident, Bruce Highway Northlakes
on 29/05/2013.

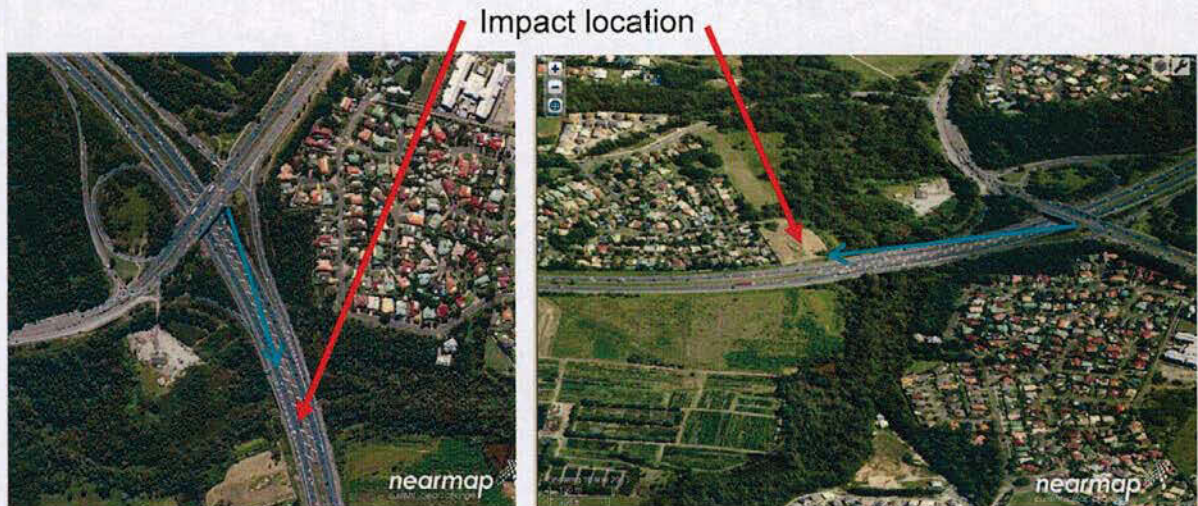
Figure 7. Camera location - nearmap images.

The CCTV camera is located at the intersection of Anzac Ave and the Bruce Highway, Mango Hill, and is facing south along the Bruce Highway. Figure 7 shows two images of the same overpass. In both images, the camera view and direction (blue arrows) and impact locations are indicated. The camera is physically mounted on a tall pole, positioned on the south eastern corner of the overpass (See Figure 8). (The second camera mounted below this is a webcam, viewable from the Transport and Main Roads (TMR) website - and is not recorded).

* Blue arrows indicate camera view direction, and Bruce Highway South.

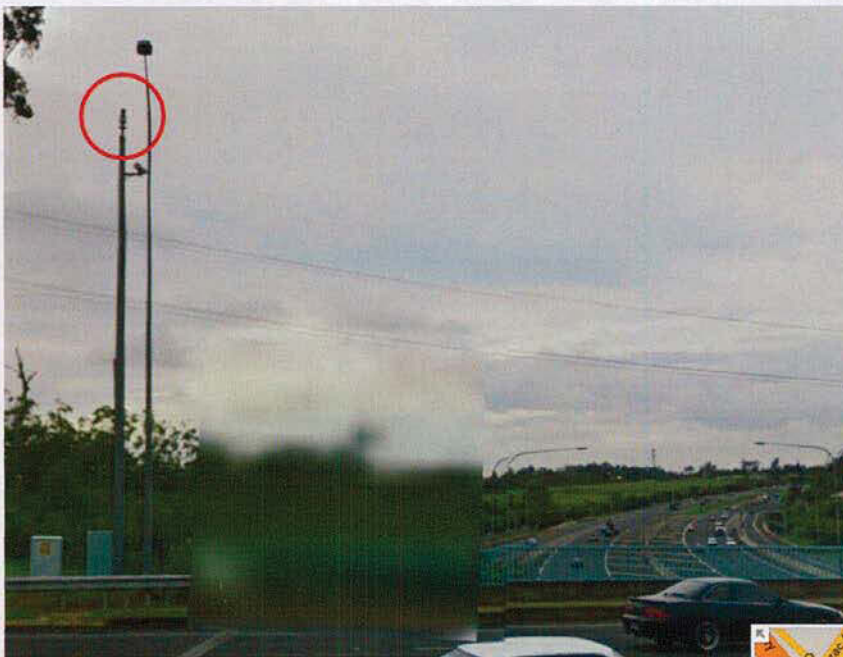
Figure 8. CCTV camera with Bruce Highway in background (looking south).

Google maps street view.

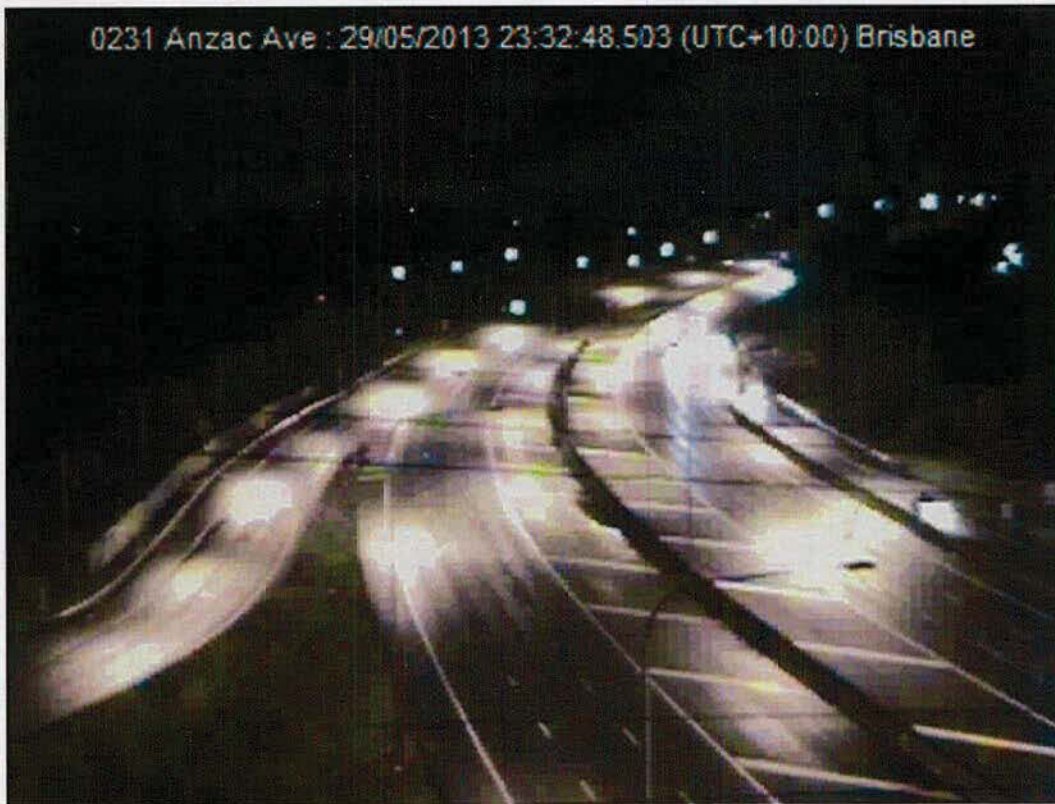
Figure 10. Sample image from the incident CCTV footage.

Figures 10 and 11 show samples of the incident footage and the police drive-through footage respectively. Note that the recorded day (police) footage is 'zoomed in' compared with the wider angled night (VOI) footage.

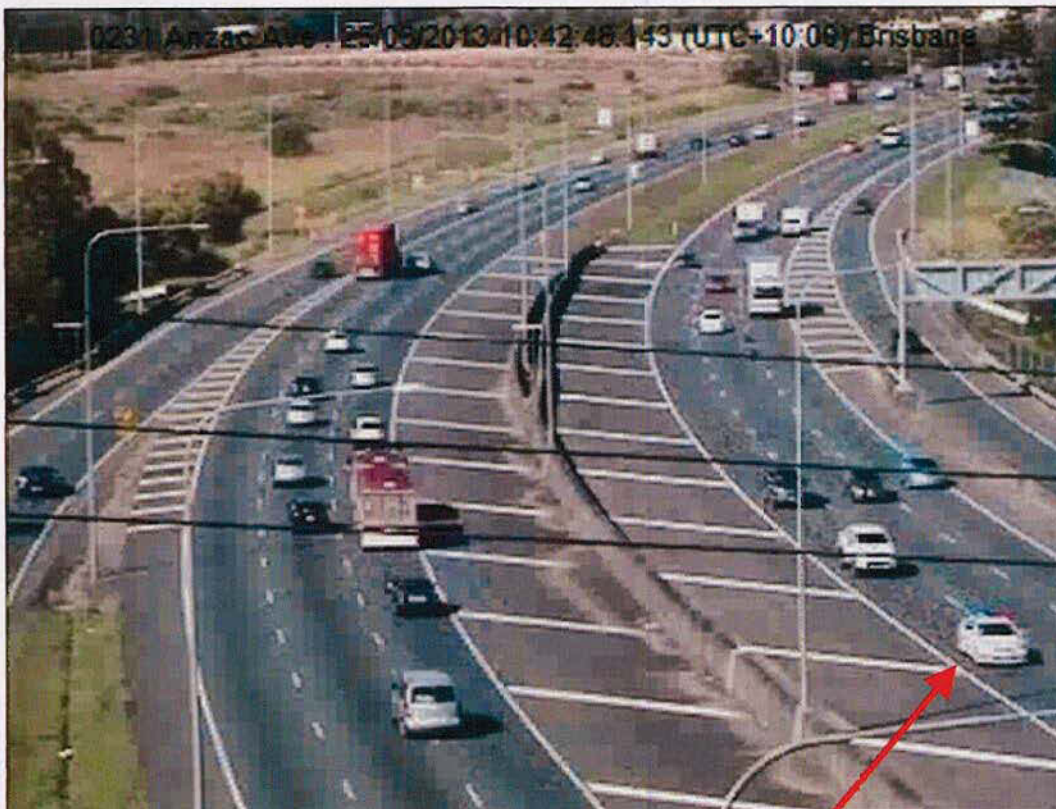
Figure 11. Sample of police drive-through footage showing police vehicle.

Police car, lights flashing for ID.

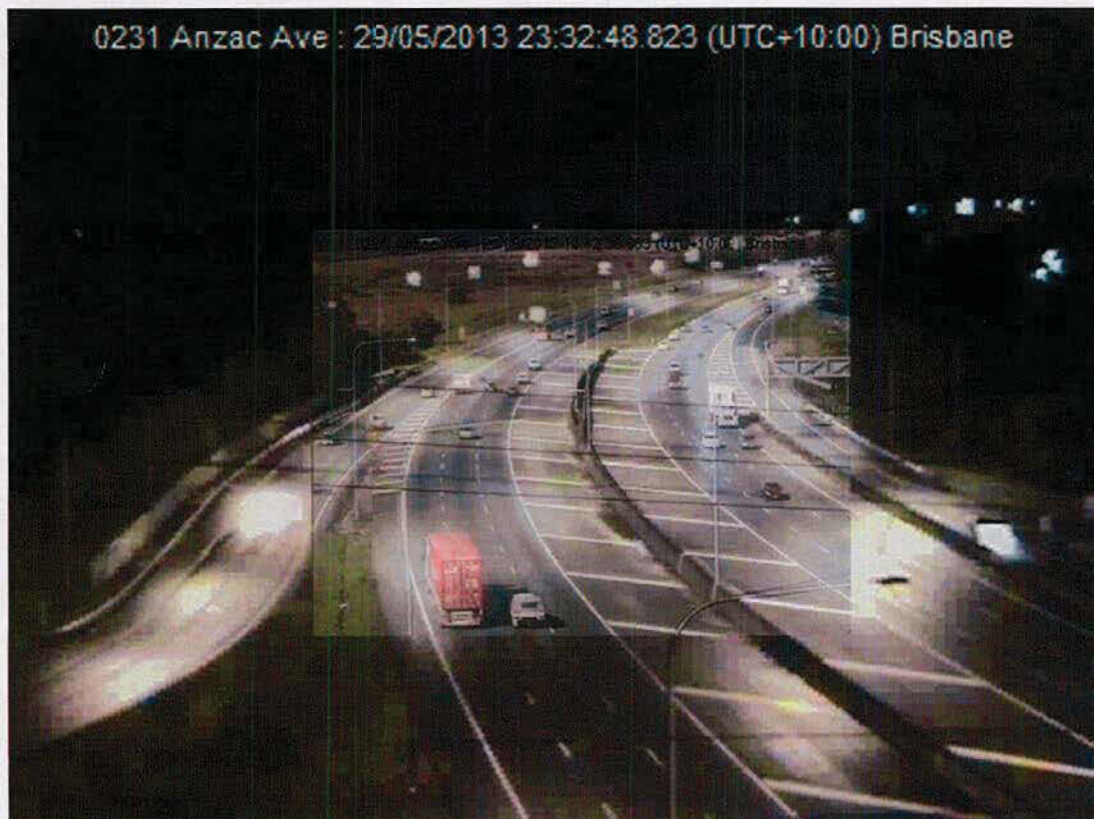
Figure 12. Day view superimposed (aligned) over night shot

Superimposing the police and incident images enables comparative positioning of the VOI in relation to the police vehicle for distance measuring purposes. This superimposition is achieved using Photoshop CS5 software. The process involves aligning, (or 'registering') the police images to match the incident footage. In order to assist in retaining the police image resolution in this registration process, the police images were extracted from the original footage at double their native size (originally 384 x 288 pixels, extracted as 768 x 576 pixels). Through this technique, high frequencies in the image (i.e. sharp edges) are less affected by subsequent translation, rotation and scaling processes.

Since the recorded incident footage is considerably 'zoomed out' in comparison with the recorded police footage, it is quadrupled in size from its native 384 x 288 pixels, to provide a base canvas size of 1536 x 1152 pixels. (The footage was originally extracted at double size, then doubled again using bicubic interpolation in ACDSee software V6.0). Figure 12 shows an example of the day footage superimposed (and aligned) over the night vision. With minimal adjustment, good alignment quality was achieved, with lamp posts, road markings, signs etc all lining up accurately.

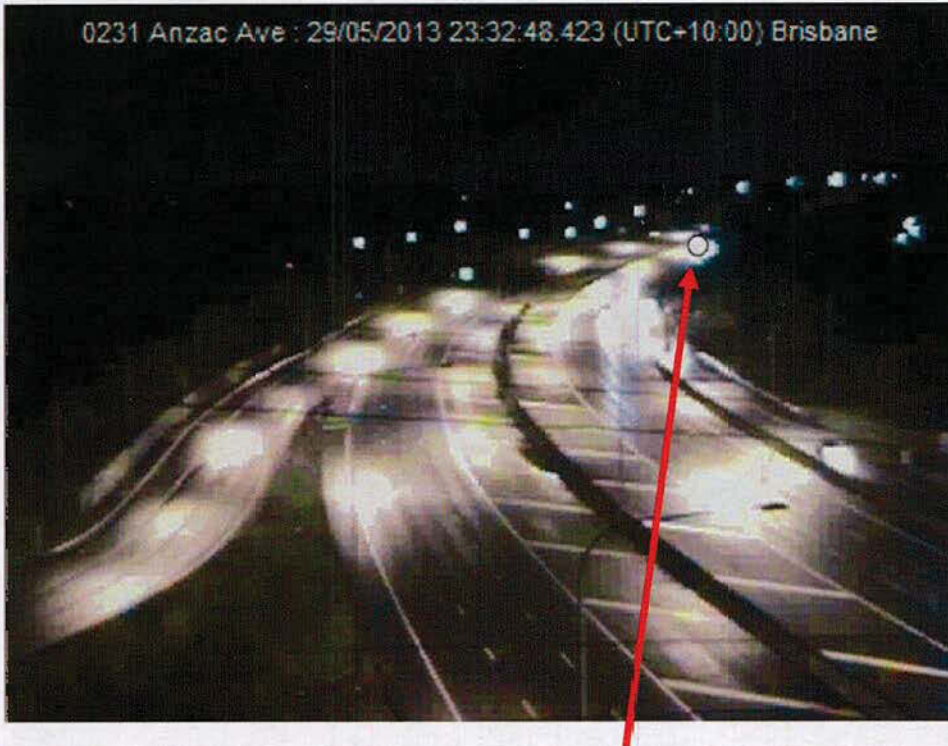
Figure 13. Image VOI-244 with headlight circled

Figure 13 shows image VOI-244 with a single circle placed over the VOI's headlight 'glow'. The image is shown in full (i.e. not cropped). The accurate positioning of this circle requires the ability to magnify this section of the vision, **and** scroll between adjacent images. Under these conditions, the circle placement becomes considerably clearer.

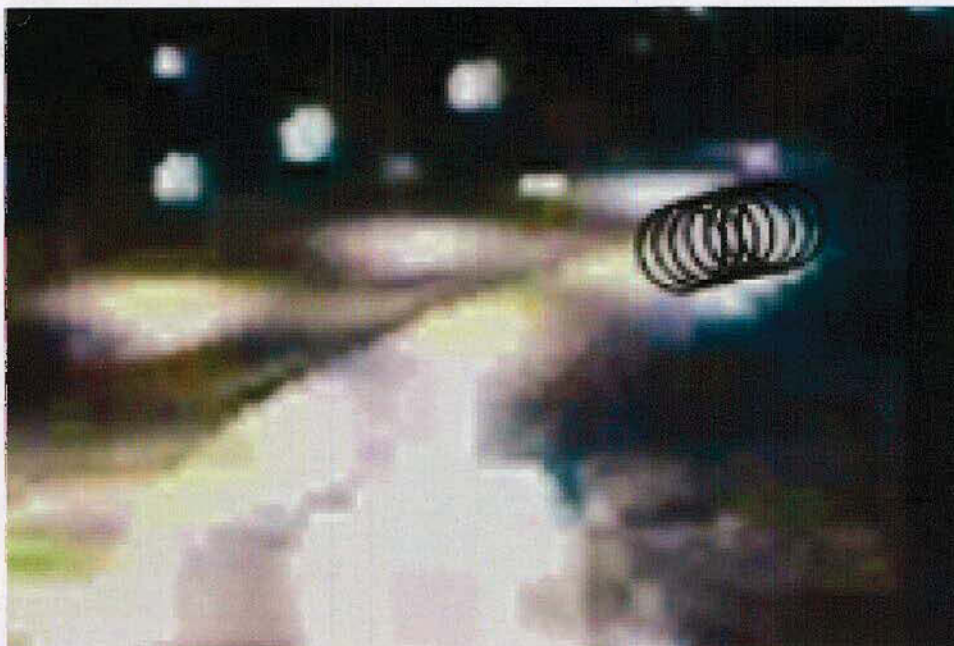
Figure 14. Seven consecutive headlight positions over central Image VOI-244.

To assist in this circle placement, additional circles are drawn around the headlight glow on the 3 images either side of image VOI-244. Using this technique, the overlapping circles indicate both the trajectory of the VOI, and spacing of its progress in time. At high speeds, it is not expected that either the trajectory or the vehicle's speed will change suddenly. Figure 14 shows the 7 circles superimposed on Image VOI-244.

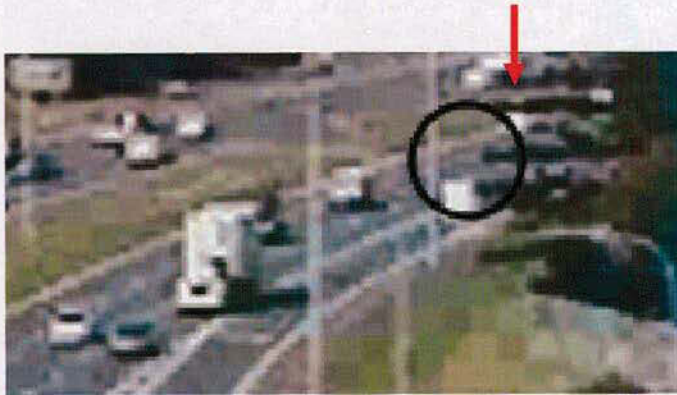
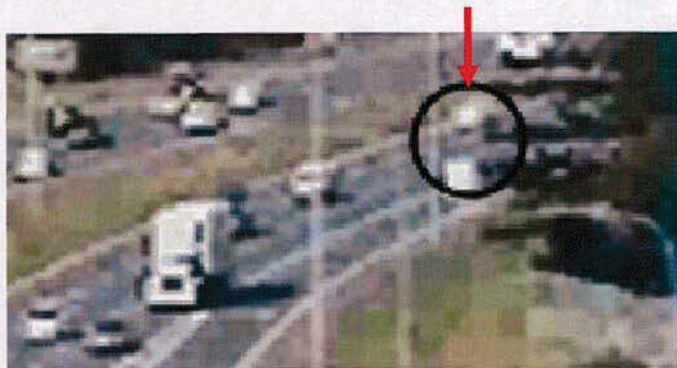
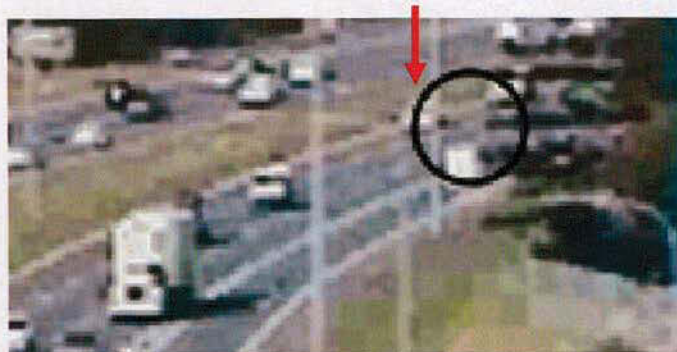
Figure 16. Police vehicle in relation to Image VOI-244 light circle.

A. Police image P-1129 - Police vehicle entering circle

B. Police image P-1135 - Front of police vehicle central to circle.

C. Police image P-1142 - Police vehicle exiting circle.

2. Given the VOI light circle, police image P-1135 places the front of the police vehicle centrally under the peak of the light circle. This is the best match of VOI and police vehicle location. (See Figure 16, image B).

3. Image P-1142 has the police vehicle exiting the VOI light circle to the left. At night, the police headlights would extend further to the left, and not be biased to the rear of the vehicle only. The police vehicle's headlights would be centred outside the VOI image (244) ball at locations past this point. (See Figure 16, image C).

It will be noted that in police image P-1135 (Figure 16-B) that the front of the police vehicle is central to the circle *horizontally*, but not *vertically*. Vertically, the police vehicle is positioned slightly above the horizontal centre. As the VOI is in the same lane as the police vehicle at this point, and that the headlight height above the road for the two vehicle's are unlikely to be significantly different, the vertical offset is attributed to the wet conditions, resulting in a lower extension of the light glow due to reflected light off the wet road.

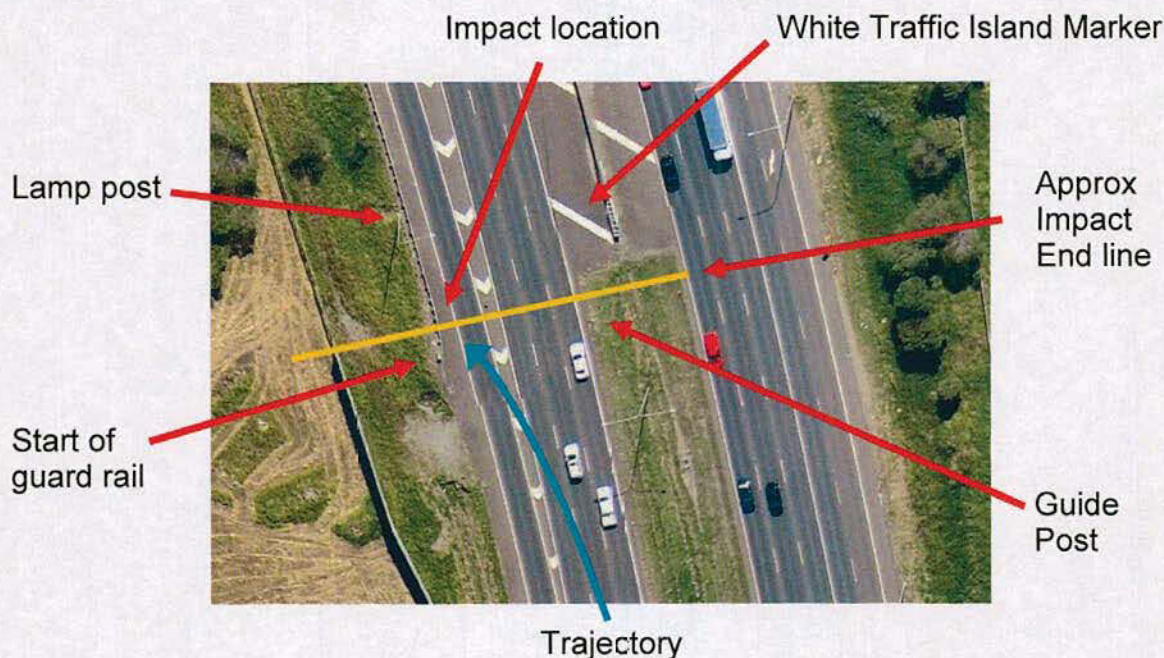
Figure 17. Nearmap image of the impact location.

Figure 17 shows the impact location, with a yellow line squarely across the road denoting the end of the measurement distance. Key items located in this image are:

- **Start of guard rail.** The VOI impacts with the guard rail, and therefore has not exited the road earlier than this point.
- **Lamp Post.** From a conversation with PCSC Judd, the lamp post is struck by the end of the guard rail as it is folded back, but is not damaged by the VOI itself. The lamp post remains standing, but the video footage shows the light extinguishing with the impact.
- **Guide Post.** The guide post on the traffic island is in alignment with the guard rail. In this analysis, it is used to help position the police vehicle.
- **Traffic Island marker.** The diagonal white line indicated is in approximate alignment with the lamp post, and represents a point past the impact location. It is used to assist in positioning the police vehicle.

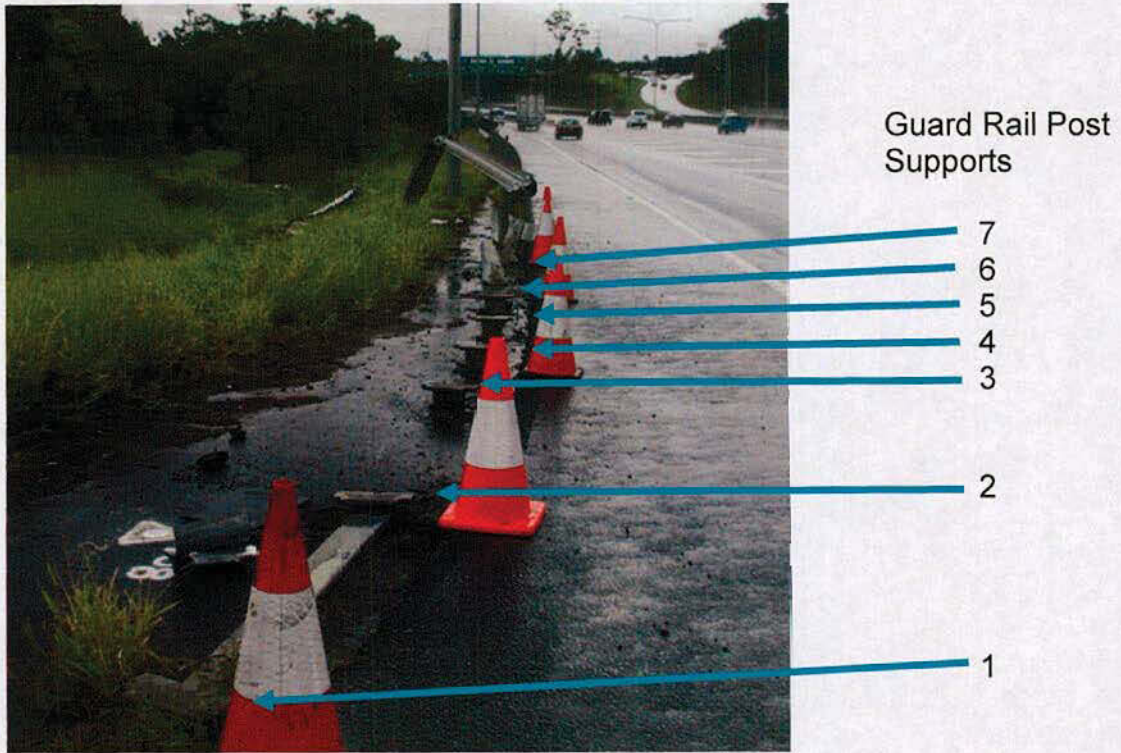
Figure 18. Damage to guard rail.

The exact physical impact location is not clear, but can be positioned to within the first several metres of the guard rail. Figure 18 shows the damage to the guard rail, as photographed the day after the incident. It can be seen that the guard rail has been folded back, sheering off at least the first 7 support posts. It would appear the vehicle did not traverse the guard rail past approximately the 8th support.

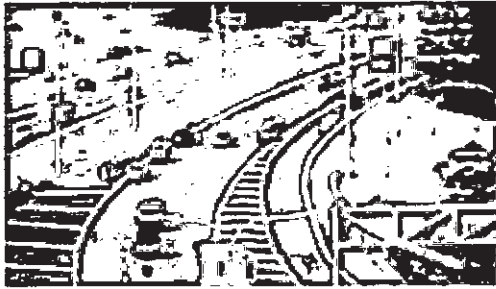
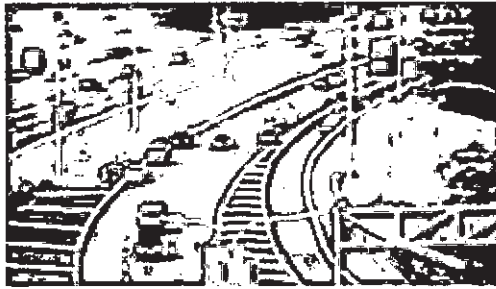
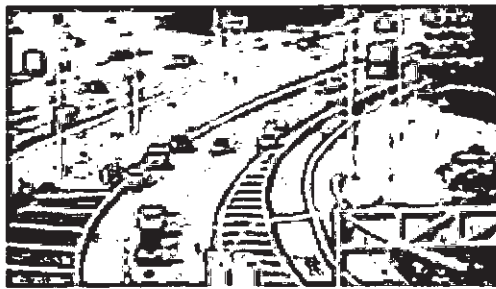
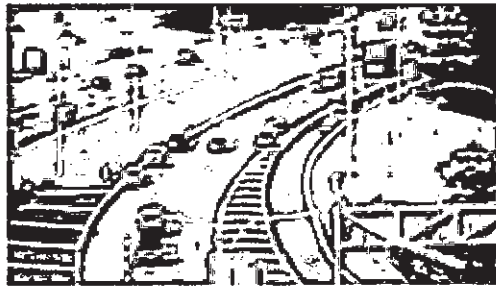
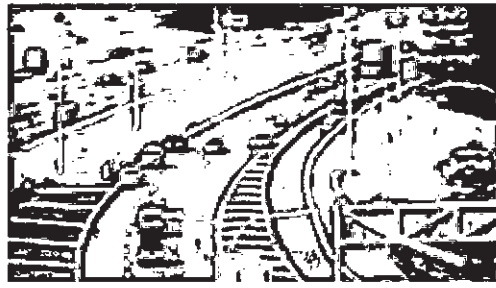
Figure 20. End location police (left) and VOI Impact (right) images.

1. The police vehicle images start with the front of the police car in approximate alignment with the guide post (Image P-1240). As this is in alignment with the start of the guard rail, this is the earliest alignment of the police vehicle with the impact location.
2. The last police vehicle location (Image P-1244) is 4 images further on from image P-1240. At 2.2222 m per image span, this equates to a distance travelled by the police vehicle of 8.8888 m. As this is in approximate alignment with the last damaged guard rail support, this is the latest alignment of the police vehicle with the impact location.

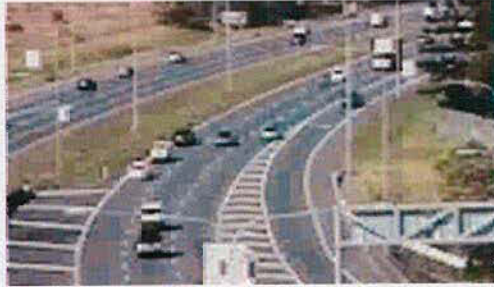
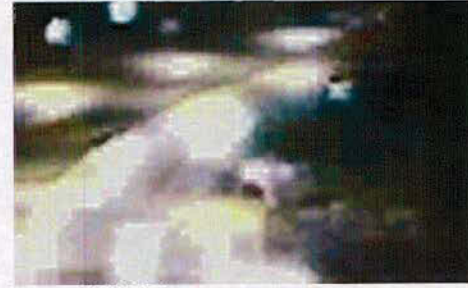
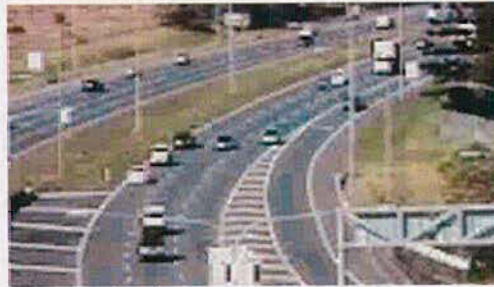
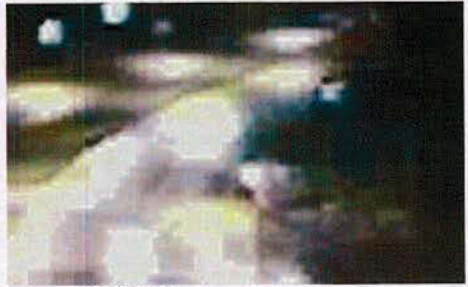
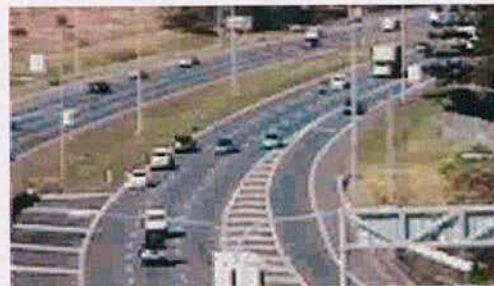
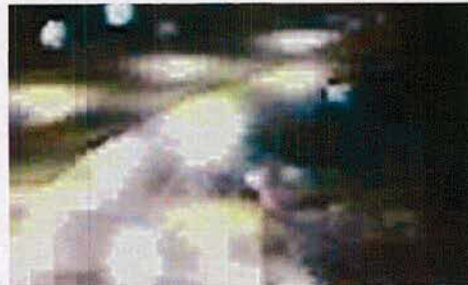
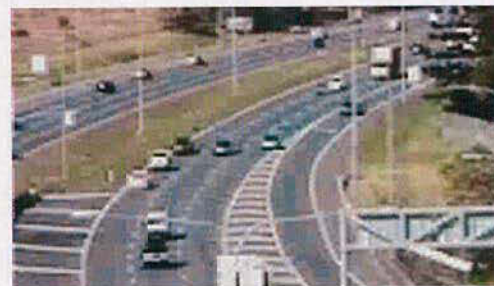
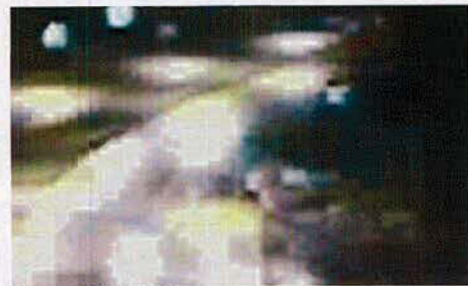
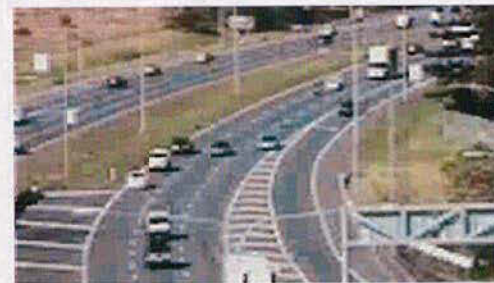
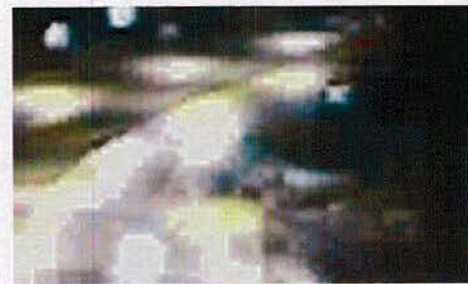
Figure 20. End location police (left) and VOI Impact (right) images.

Figure 20 shows the end locations for both the police vehicle and the VOI. The two columns of images (police vehicle on the left and VOI on the right) are not especially intended to be in horizontal alignment, but rather to show images that are clearly before and after the impact for each vehicle. In respect of these images:

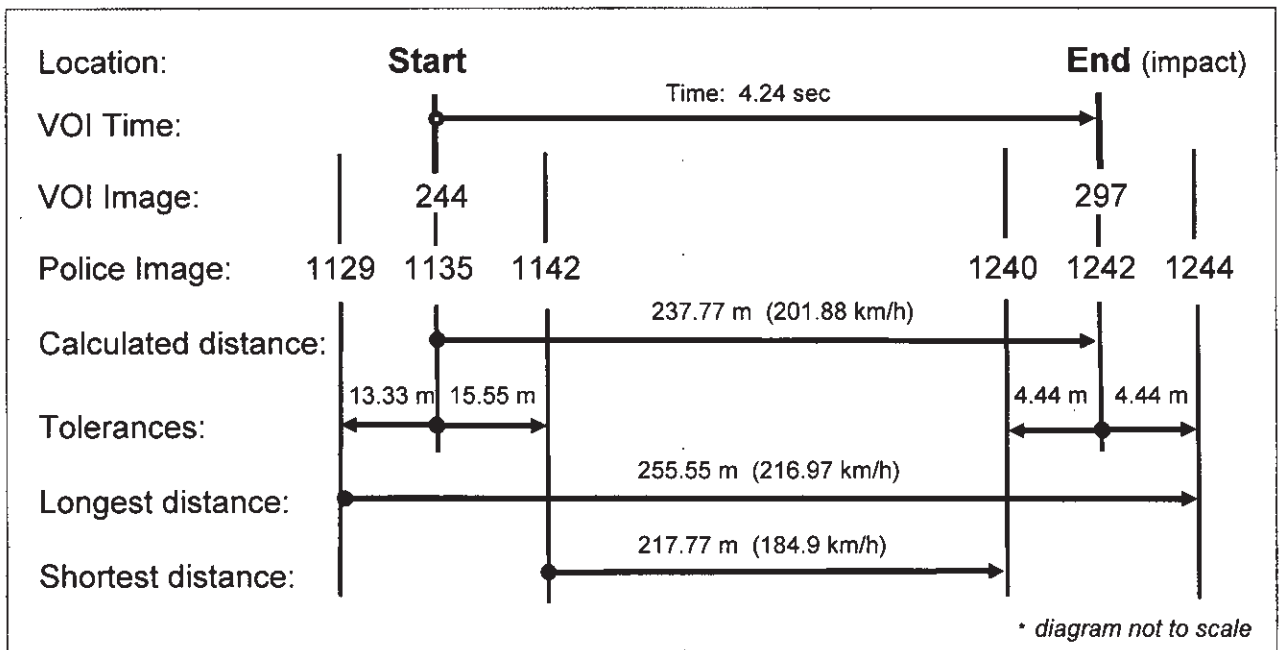
Figure 21. Diagrammatical representation of measured distance tolerances

- The 'fast' tolerance (given the fixed time duration of 4.24s) is found by using the longest distance. In this case it is from the earliest possible equivalent police vehicle position before the start point (image P-1129) to the latest possible equivalent position at the impact location (image P-1244). Subtracting these two gives the maximum distance of 115 spans.

Figure 21 shows the distance measurements diagrammatically, including the tolerances.

- 2. The 'slow' tolerance is found by using the shortest possible valid distance. In this case it is from the latest suggested police vehicle position before the starting point (image P-1142) to the earliest possible position at the impact location (image P-1240). Subtracting these two gives 98 spans.

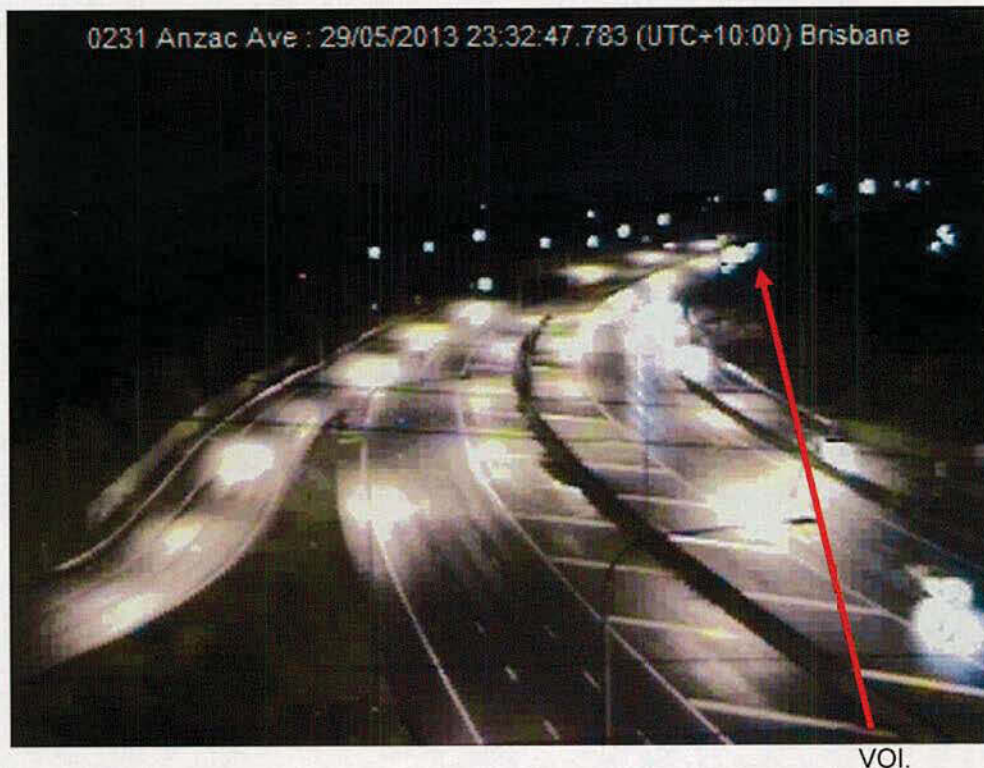
Figure A1. VOI first seen (image VOI-236), time stamped 47.783 s

1. The VOI enters the CCTV vision at image time 47.783 s (image VOI-236). This is 4.881 seconds prior to the impact point at 52.664 s (image VOI-297).

Figure A1 shows the VOI first appearing in image VOI-236.

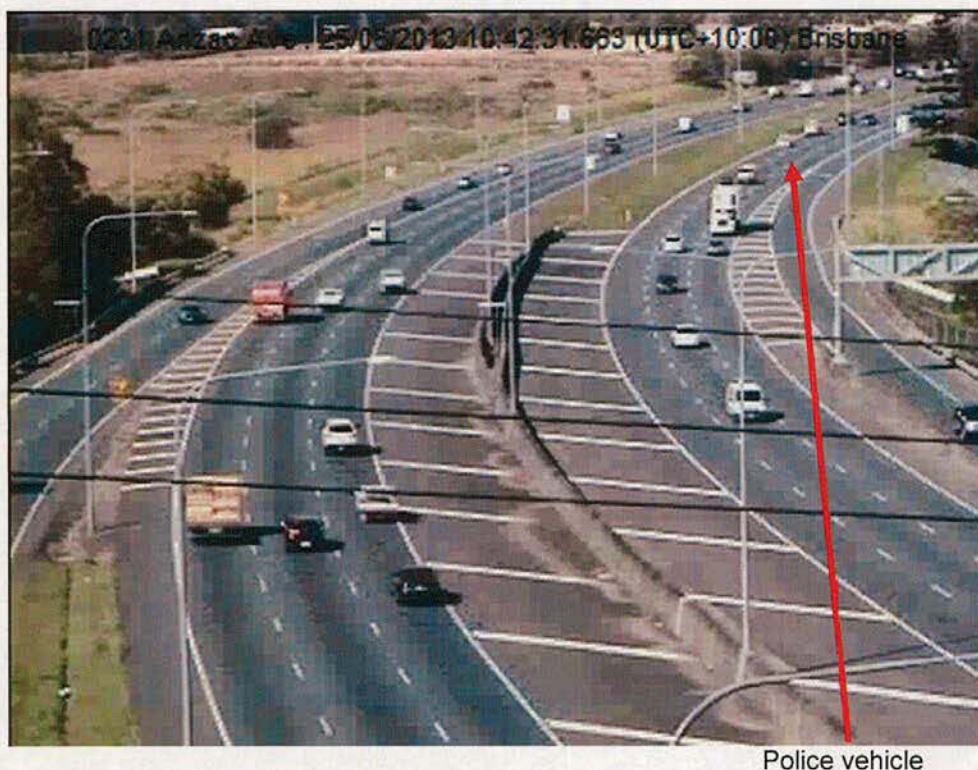
Figure A2. Police vehicle location in image P-1181

- The police vehicle travelling at 100 km/h travels 27.7 m/s, or 2.2222 m in 0.08 seconds (1 span).
- At the point of impact, the police vehicle is positioned at approximately police image P-1242. Moving backwards from this image by 61 images (or 4.88 s) puts the police vehicle at police image P-1181, or 135.55 m prior to the impact point ($61 \times 2.2222 \text{ m}$). Figure A2 shows the police vehicle location at image P-1181.

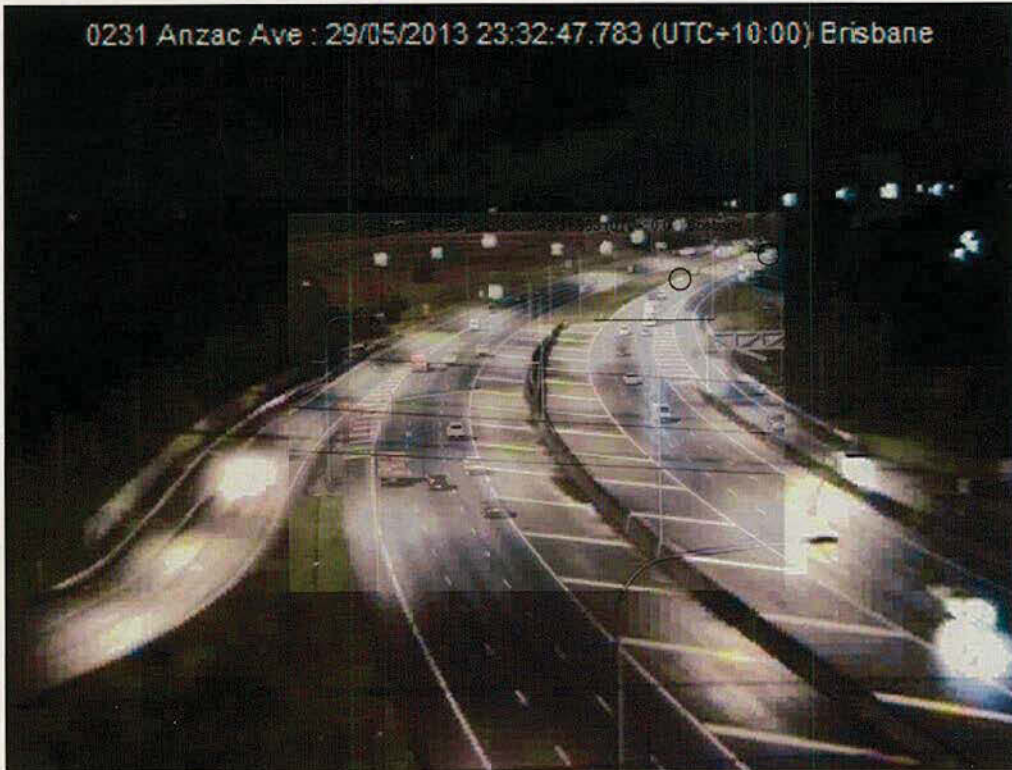
Figure A3. Superimposed images (VOI-236 & P-1181).

- By comparing (overlying) police image P-1181 and VOI image VOI-236, a visual comparison of the relative vehicles locations 4.88 seconds prior to the impact location can be made. Figure A3 shows the two images overlaid in their full size, whilst Figure A4 shows the same image cropped into the area of interest. In this last image, the two vehicles and the impact line are indicated.
